Allied Paper, Inc./Portage Creek/ Kalamazoo River Superfund Site  
Area 3/Former Otsego Impoundment: Proposed Survey and Field Sampling Plan

Date:  
September 13, 2012

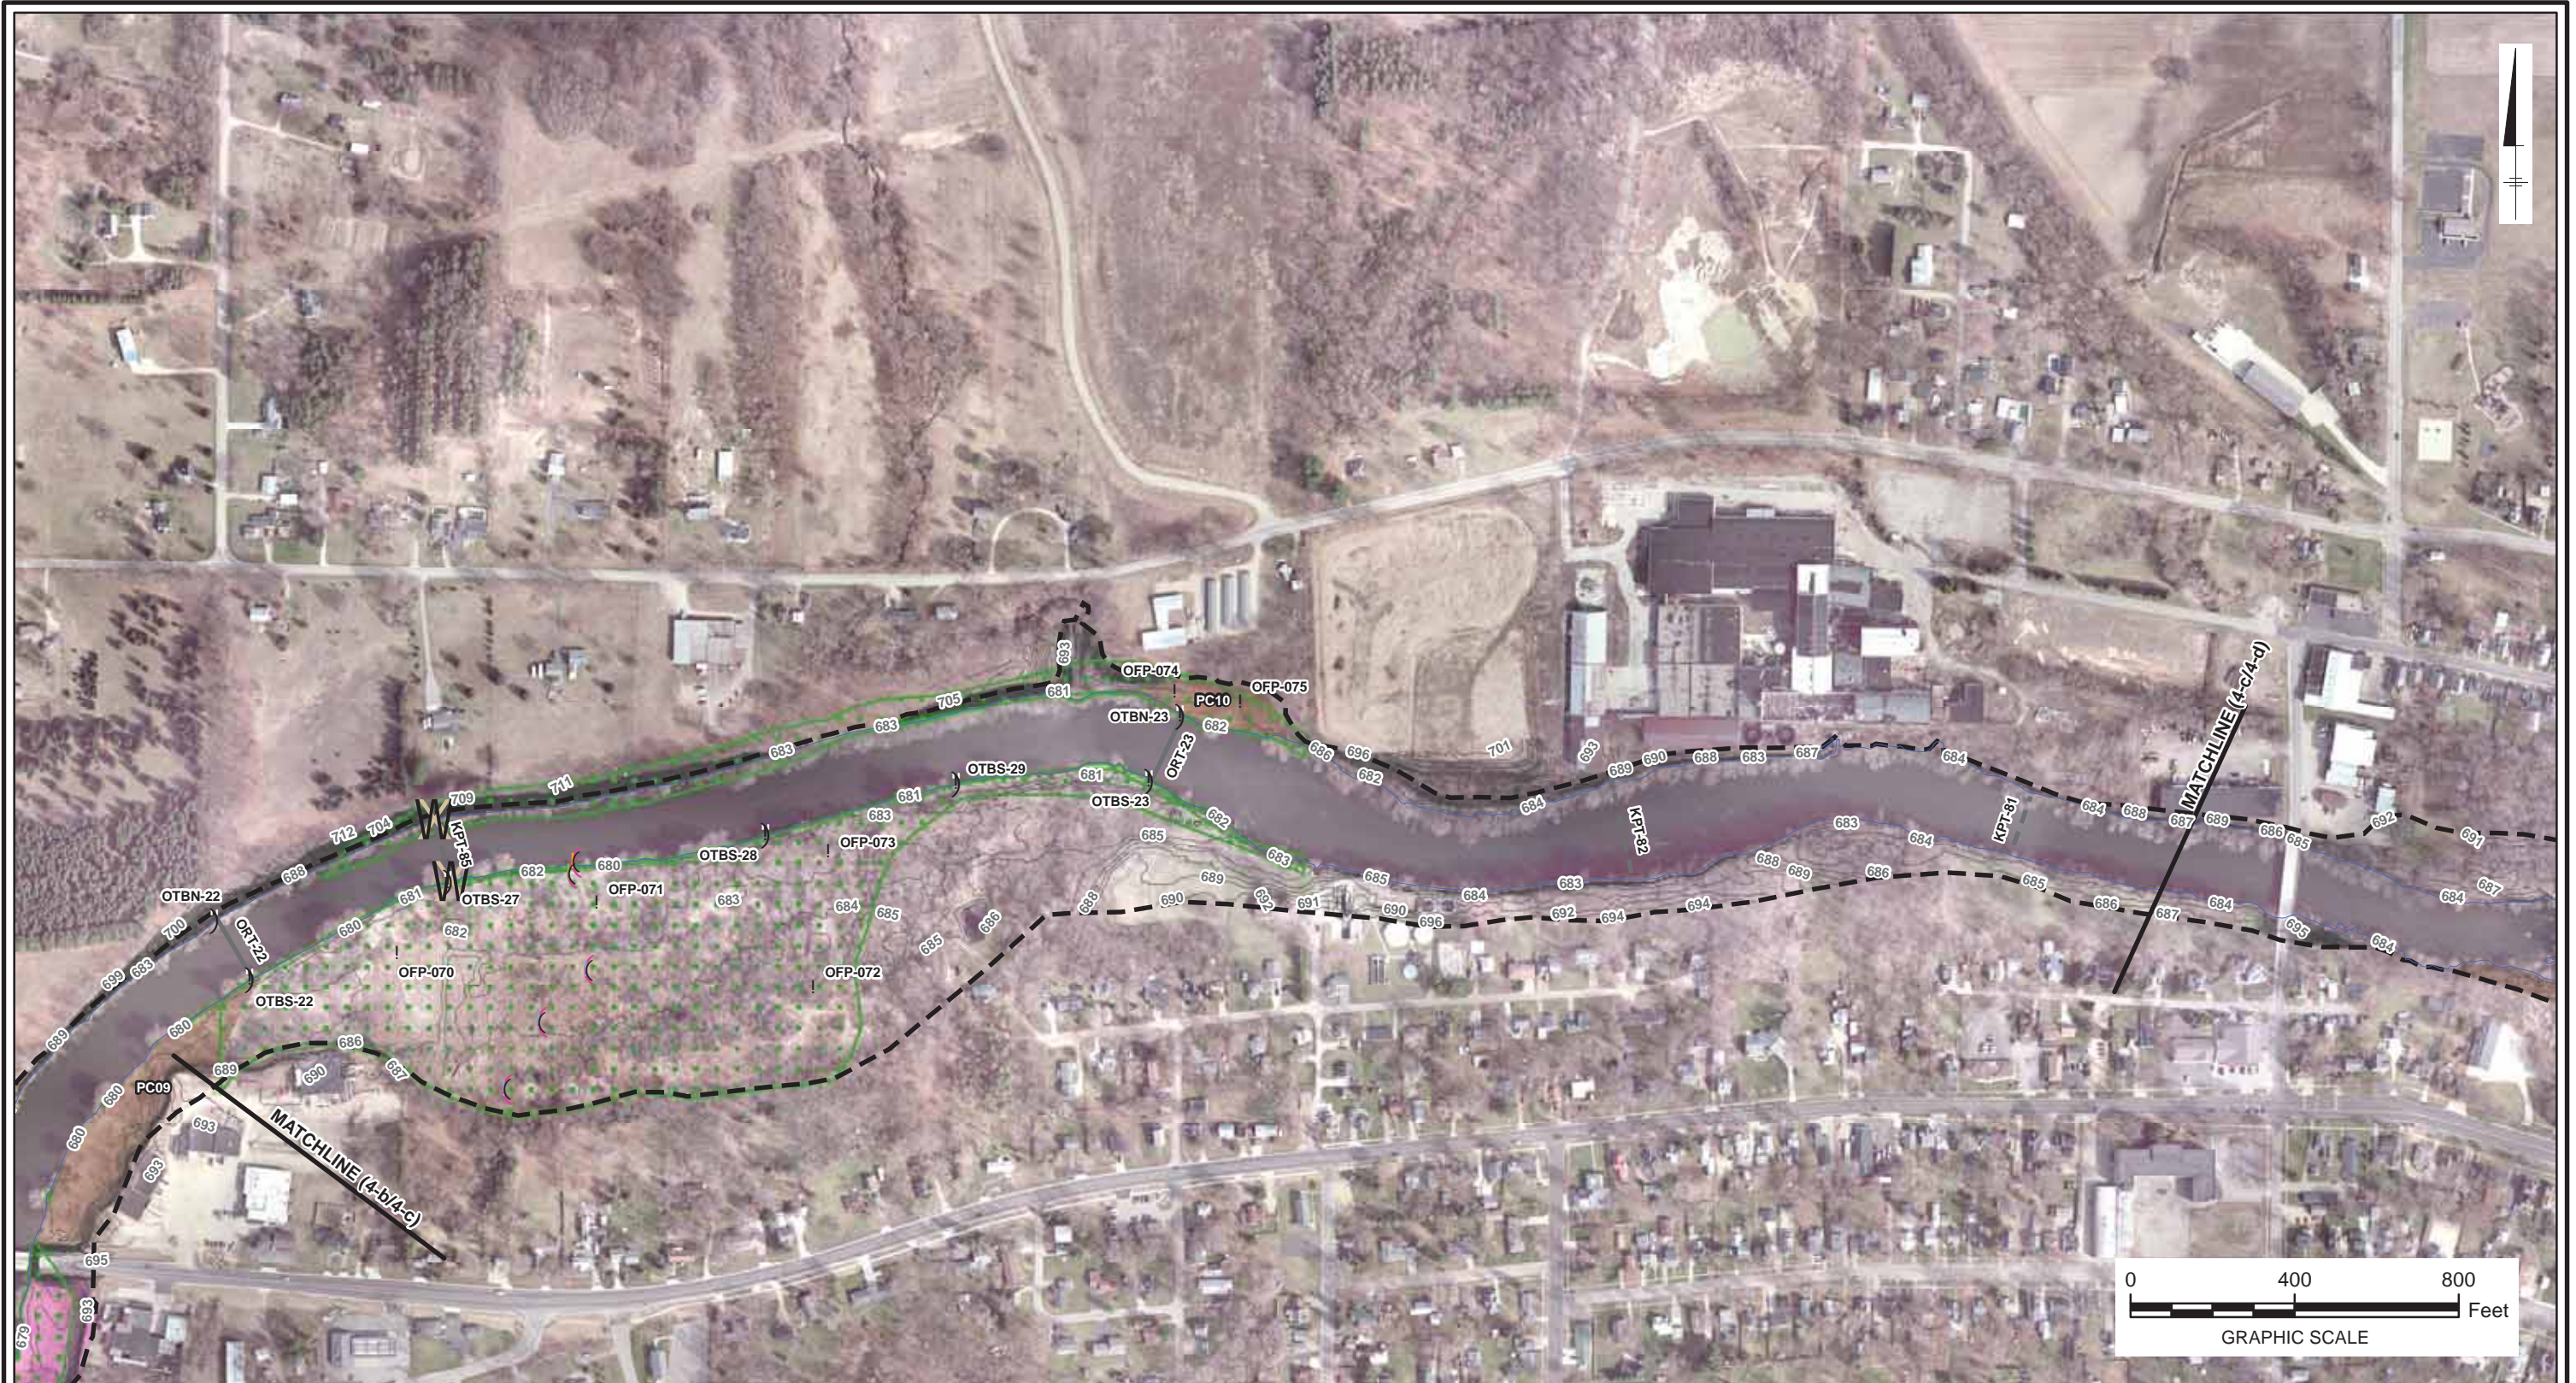
FIGURE  
**4-c**

- Soil sample OFP-69 was added in Previous Channel 09 to increase the sample density in this feature.
- Three new soil samples (OFP-70, OFP-71, and OFP-73) were added in the extended floodplain area adjacent to Previous Channel 09 (MDNR Property) below the 683-foot elevation and one new soil sample (OFP-72) was added above the 683-foot elevation to gather additional data from this area (see Figure 4-c).

- Three new bank samples (OTBS-27 through OTBS-29) were added on the south bank between Previous Channel 09 and the Wastewater Treatment Plant (see Figure 4-c).

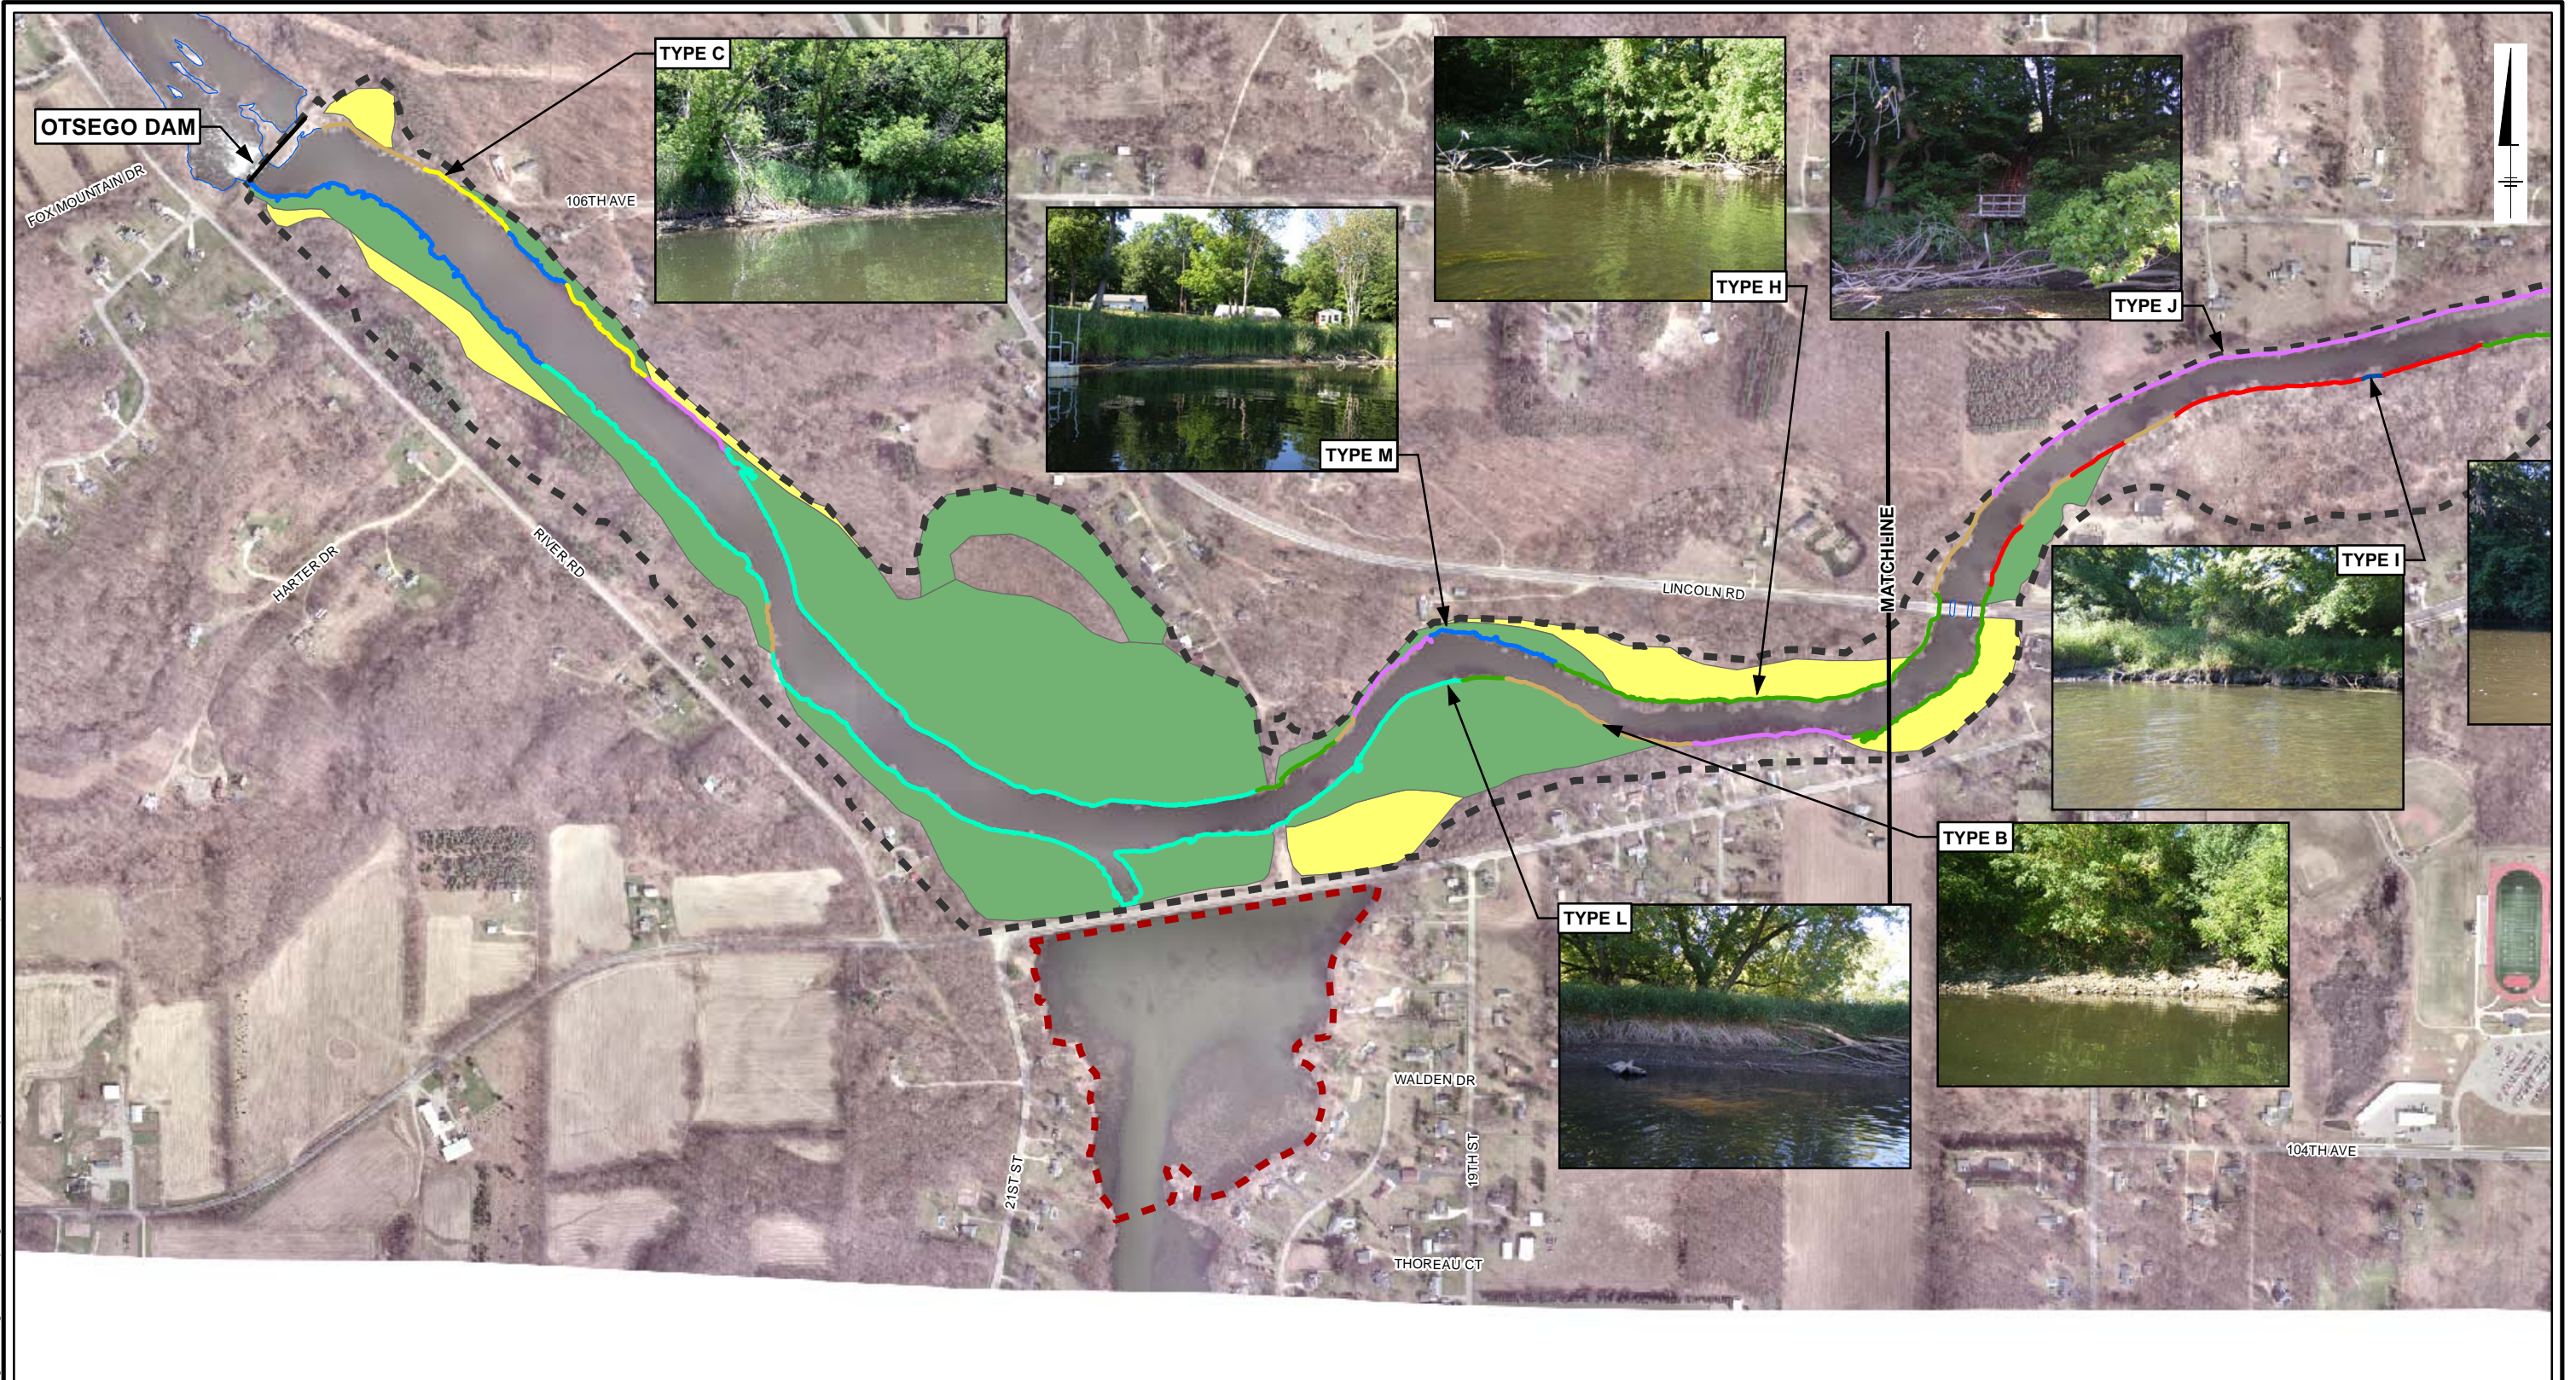
FIGURE  
A-2a

- A review of bank characteristics was conducted as part of the reconnaissance activities and nine bank types were identified within Area 3 (Table A-1 and Figures A-2a and A-2b in Attachment A). Bank types ranged from low vertical vegetated or rock-covered to steep but vegetated high banks. A number of residential properties, primarily located some distance upstream of the M-89 Bridge, were identified with mowed lawns extending to the top-of-bank. In some instances, gray materials were identified in the bank face, as in other bank areas in this reach.

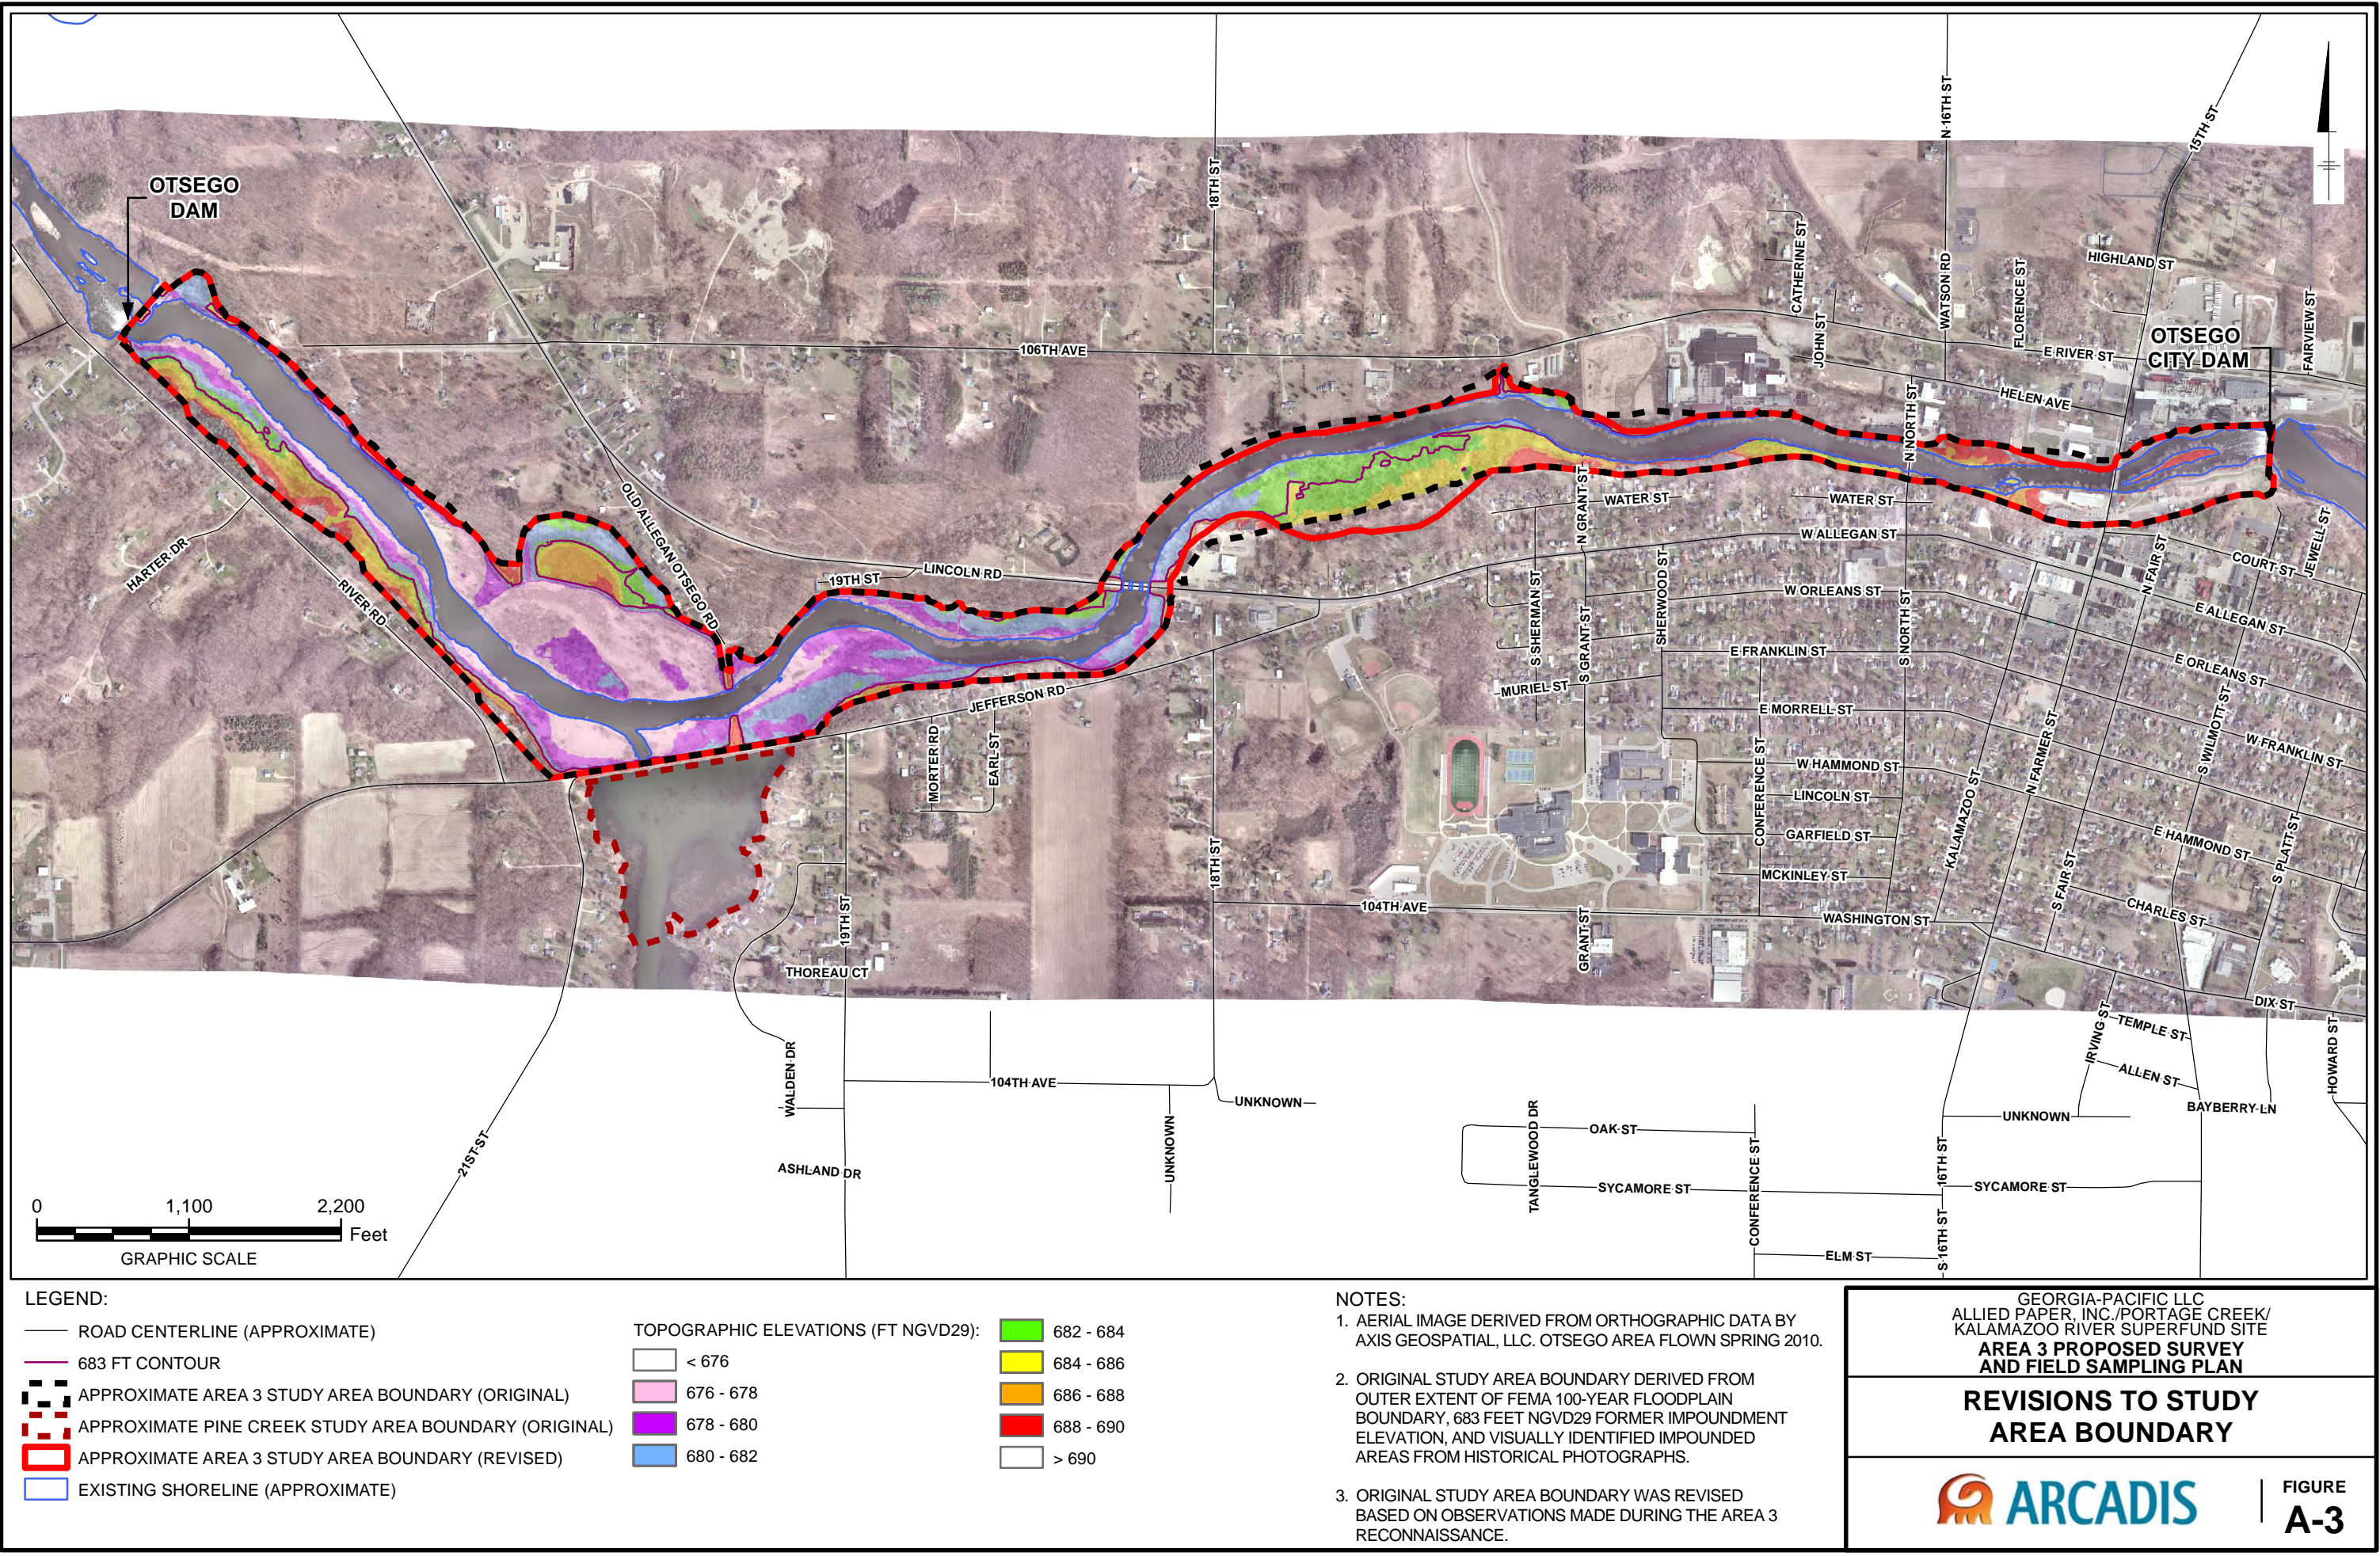
As described in the Area 3 SRI/FS Work Plan (ARCADIS 2012a), the Study Area boundary was derived from the outer extent of the Federal Emergency Management Agency (FEMA) 100-year floodplain boundary, 683-foot (NGVD 29) contour, and the approximate extent of visually identified impounded areas from historical aerial photographs. The Study Area boundary was revised in certain locations based on the key features identified during field reconnaissance activities (see Figure A-3 in Attachment A).
